# Characterizing the Water Quality of the Cagayan River: Basis for Community Action Programs Toward Prevention of Water Pollution

Marie Grace S. Cabansag<sup>1</sup>

<sup>1</sup> Department of Teacher Development, Philippine Normal University, 3306 Alicia, Isabela, Philippines

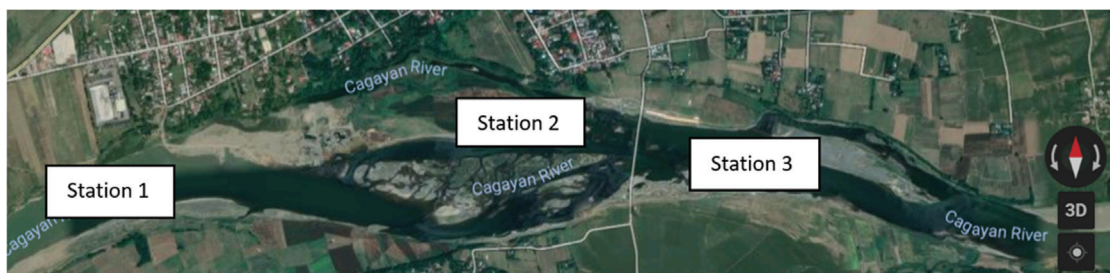
**Figure 1.** The three sampling stations: 1) the catchment area for industrial wastewater coming from a feed processing plant and cornfields along the riparian zone, 2) the catchment area for domestic and agricultural wastewater, and 3) the area where wastewater from municipal (commercial activities) and agriculture is disposed.

The selection of exact sampling stations considered the following factors as suggested by Estrada (2001), these were: representativeness, flow rate, accessibility and safety, homogeneity, and sampling facilities. The sampling was done within a ten-meter distance from edge of each of the three catchment areas of wastewater (Figure 1) leading toward the main body of the river. A collecting vessel was used to get a sample from each of the three strata the surface, middle and bottom layer. Water samples from

the surface were obtained opposite the flow of river current. The samples from the middle layer were taken from a depth of about 2-3 m deep while the samples from the bottom were taken from a depth of about 5 m. Proper labeling, handling and preservation were observed as strictly as possible to ensure the integrity of the water samples. The collection of water samples was done on a sunny day of February in 2015. Sawyer, C.; McCarty, C. and Parkin, G. (2003), and Estrada (2001) suggested that once daily grab sample is adequate for large rivers where change occurs slowly. The Cagayan River is large and considered the longest river in the country which is why the once daily grab sample was deemed suitably performed.
